Report A-008/2013

Accident involving a BOEING B-757-300,
registration D-ABOC, operated by
Condor, at the Gran Canaria Airport
on 22 March 2013

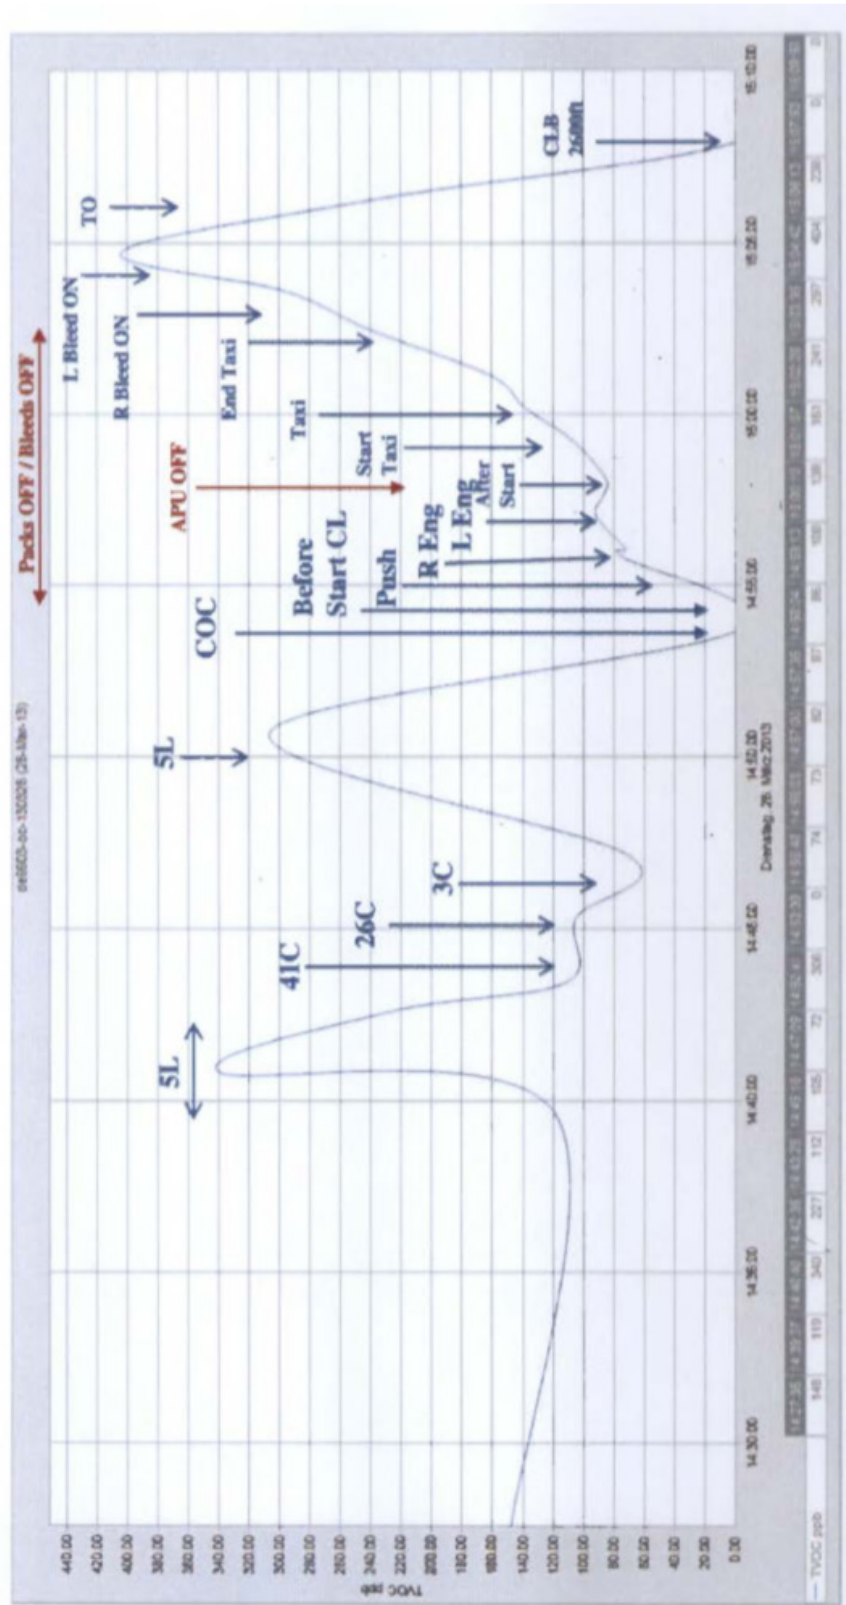
**TVOC-Measurement on ground and until Climb-Out phase
 (note: different scale for easier differentiation)
 Increase of TVOC (with Packs OFF/Bleeds OFF) correlates with perceived smell in A/C**

Figure 3. Graph with the TVOC readings of the Graywolf sensor from the time the crew boarded the aircraft until the initial climb phase

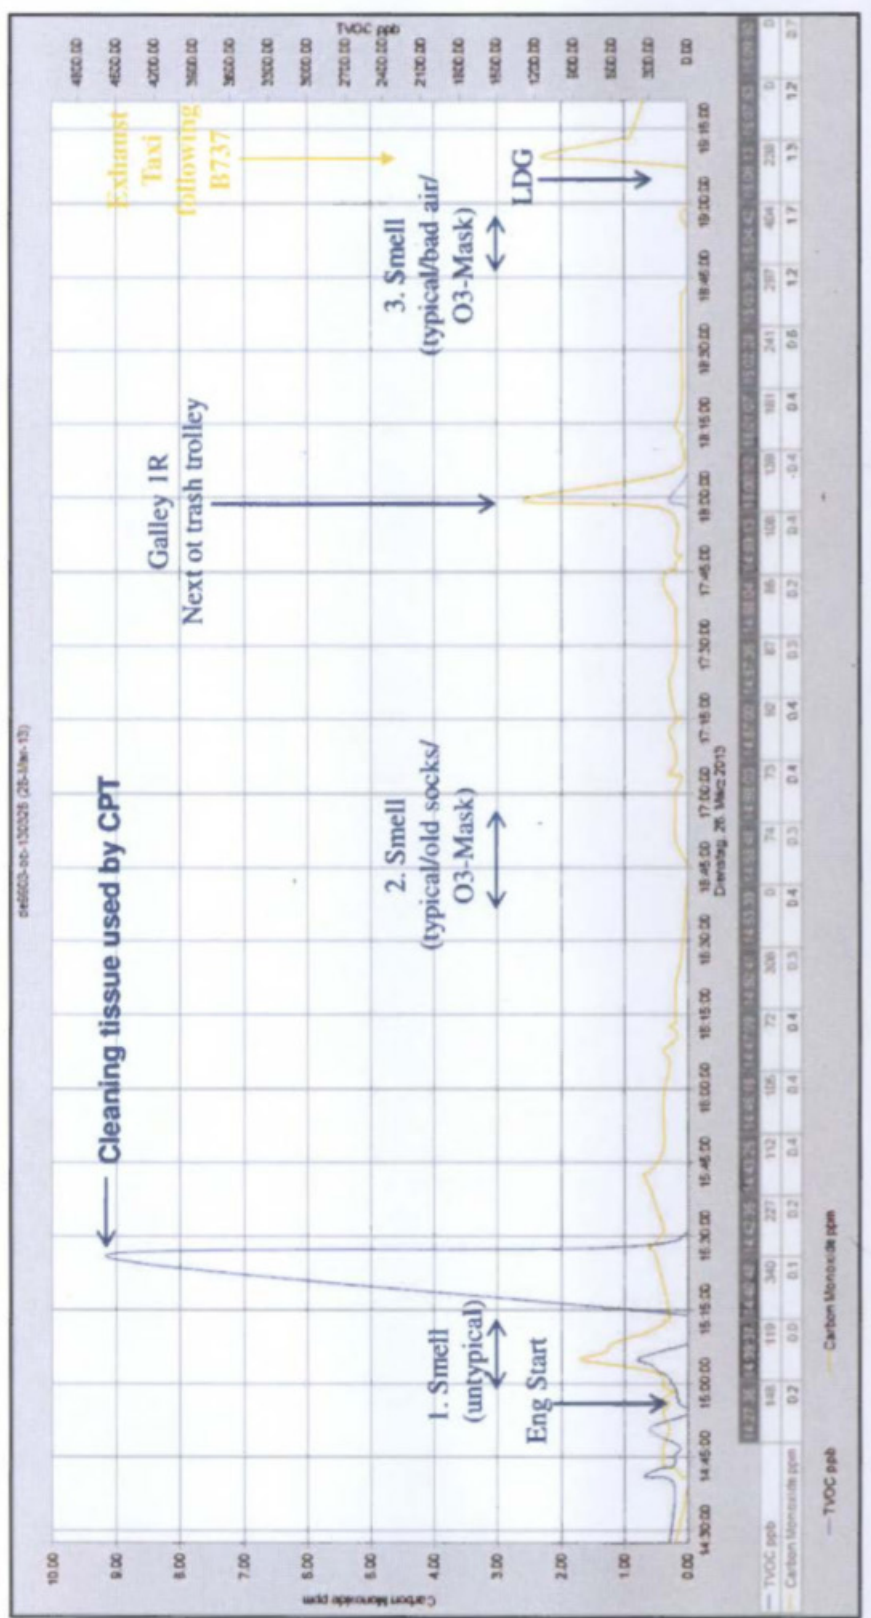
The reason why the Graywolf did not give any indications during these phases could be because the odor was caused by compounds that are not ionized in the unit's probe (those with an ionization energy higher than 10.6 eV). Examples of such compounds include the following:

Figure 4. Comparison of TVOC and CO readings throughout the flight

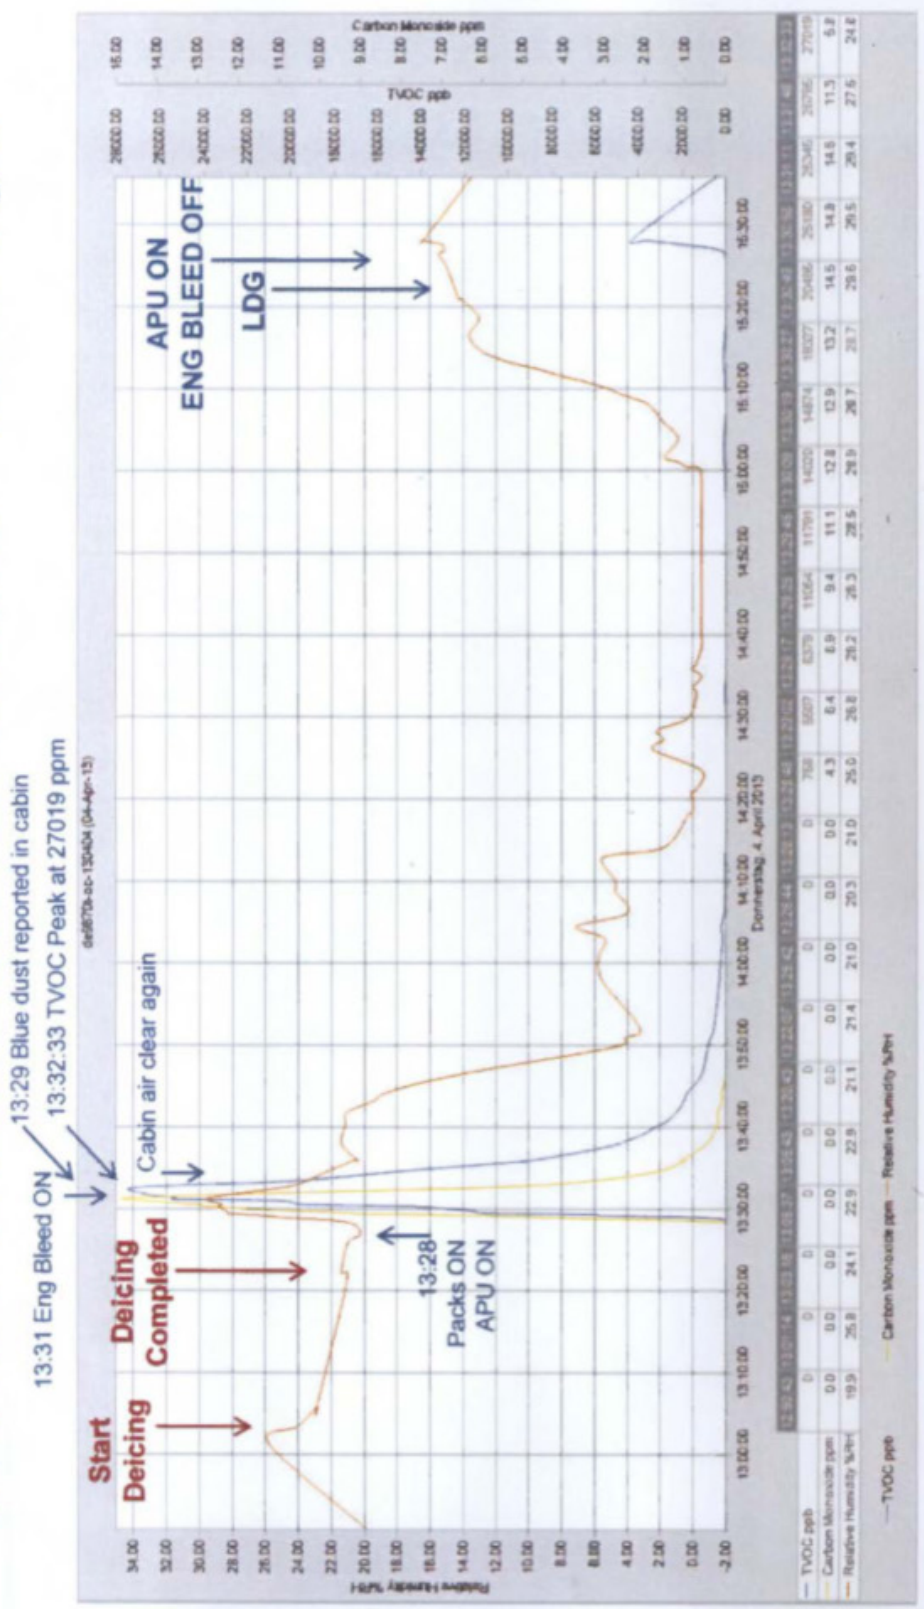
This time a large amount of smoke entered the cabin, both on the ground with the APU supplying the air conditioning packs, and in flight, with the air supplied by the engines. The Gray Wolf displayed a rise in TVOC values.

Figure 5. TVOC, CO and relative humidity readings during the flight of 04/04/13, which had undergone a deicing treatment

In light of the results of this test, the operator decided to prohibit deicing treatments with the APU running.

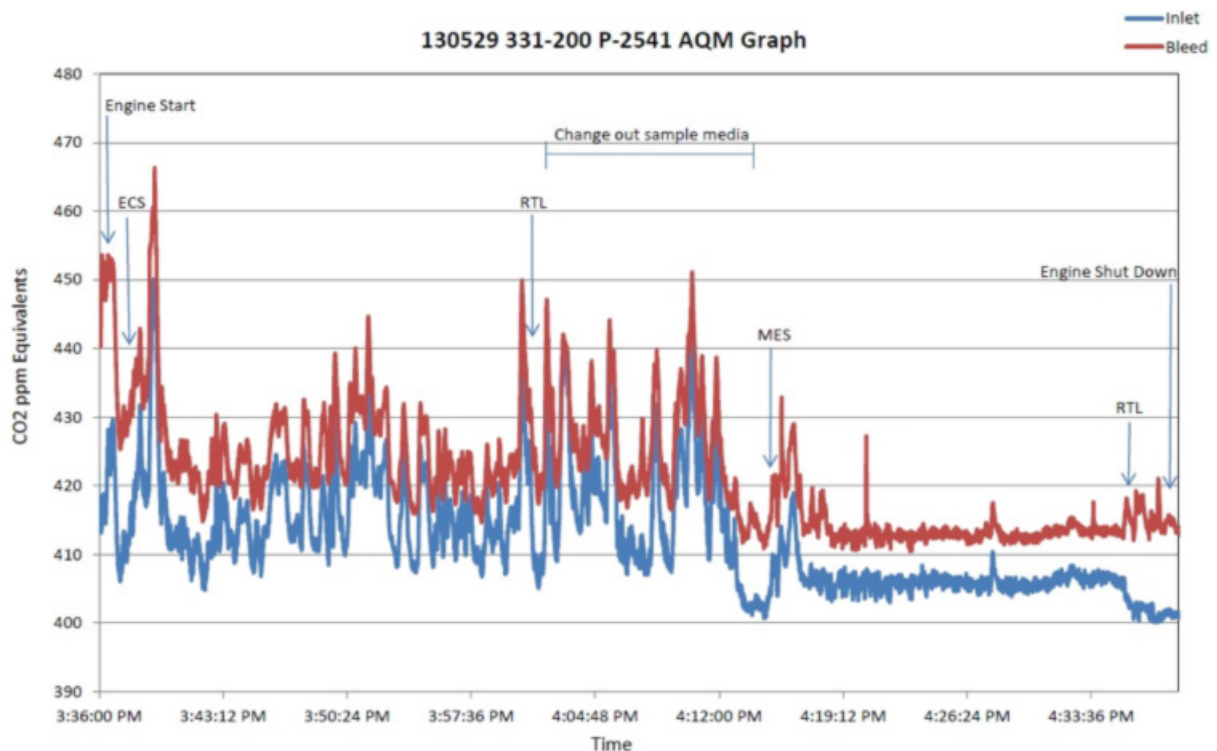
- Tricresyl phosphate isomers were detected only during the “main engine start” operation, in the 0.0090-0.255 ppb range, which is well below the OSHA-PEL, which is 6.6 ppb.
- Traces of multiple compounds and TICs⁹ were detected, with the highest levels being for isopropyl alcohol (2-propanol), acetone, butanone, toluene and carbon disulfide, all of which were below the odor perception threshold.
- The only smell reported by any of the participants was a “dirty” smell, with no reference being made to an “oily” smell.

Figure 7. Results of the AQM
