Report A-008/2013

Accident involving a BOEING B-757-300,
registration D-ABOC, operated by
Condor, at the Gran Canaria Airport
on 22 March 2013

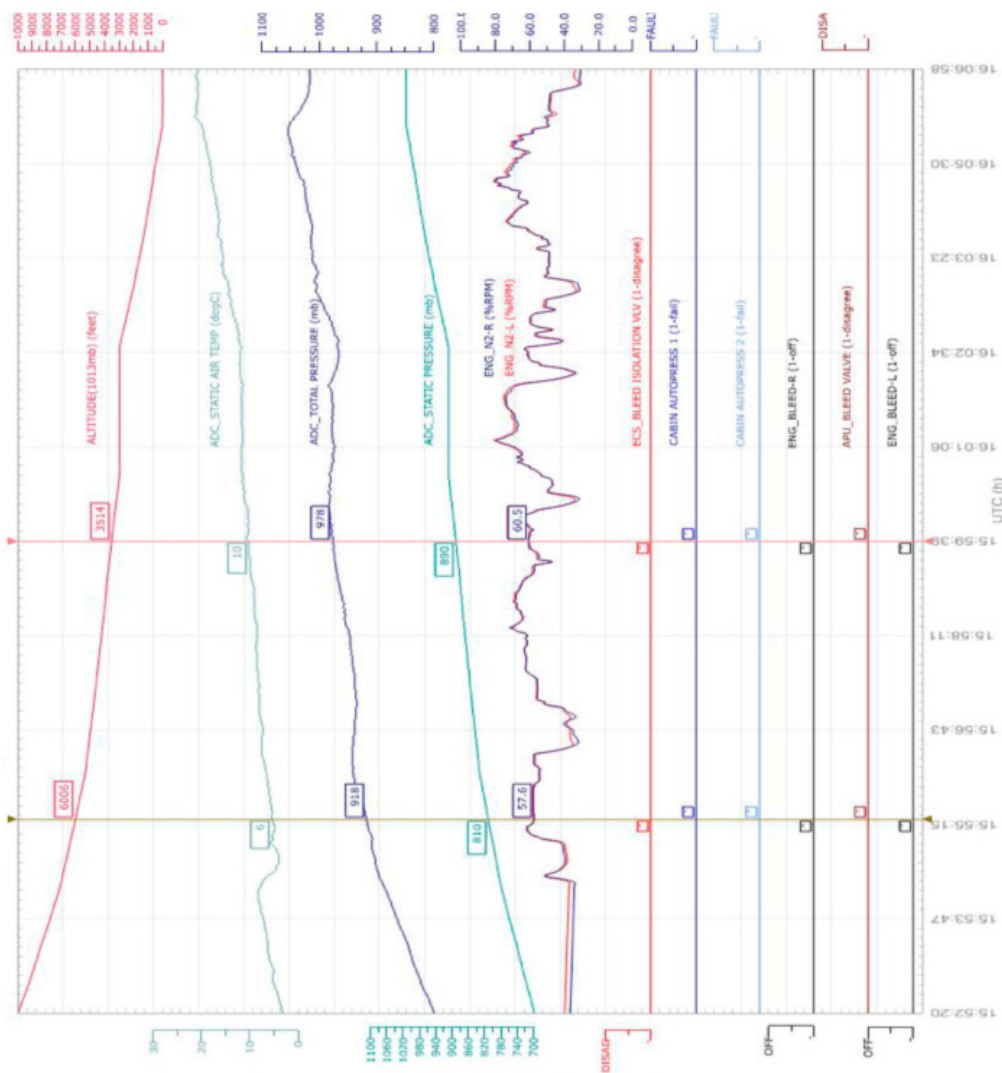
Figure 6. Graph showing several parameters during the approach

The information contained in the recorder did not indicate the presence of any abnormalities.

Figure 6 shows a graph of the values for several outside air parameters (pressure altitude, outside temperature, total pressure, static pressure), as well as for aircraft systems (N2 for both engines, position of the engine bleed valves, automatic cabin pressure fault indications, and agreement between the positions of the APU bleed valves and bleed isolation valves). The graph spans from the time the aircraft was on approach at an altitude of 10,000 ft until seconds after landing.
